Subject: Management Report for the Gold King Mine Release - 8/15 to 8/16 Operational Period

Gold King Mine Release

EPA Internal Update: As of August 17, 2015 1345 ET

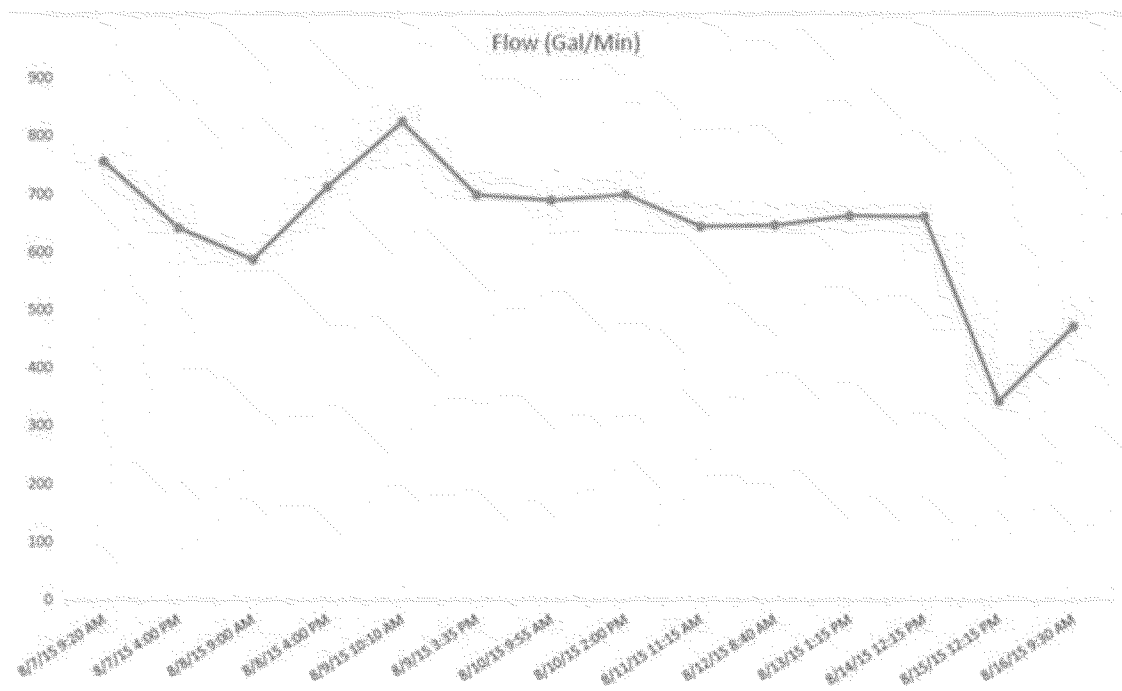
Flow from the mine through the morning of August 16 is shown in the following chart.

Treated water from the last treatment pond is discharging into Cement Creek. Flow data out of the mine is being collected manually two times per day. Water quality data is being collected at the influent and effluent of the treatment system as well.

The EPA continues to operate four treatment and sedimentation ponds at the mine site which are treating water by lowering acidity levels and removing dissolved metals. A technical expert from CDPHE is assisting at the Gold King Mine site in optimizing the water quality treatment system.
